Arctic Fox 10ft Shelter System – Functional Solar Test

Arctic Fox 10ft Shelter System
Part number: AF00001C002
Serial number: A608G000001
ODA-code: A608G

SOLAR FUNCTIONAL

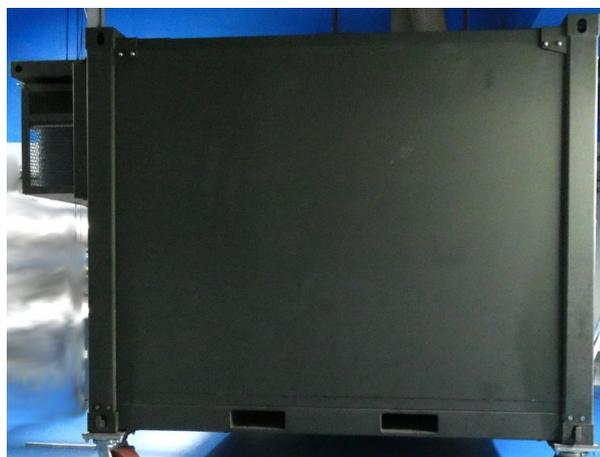
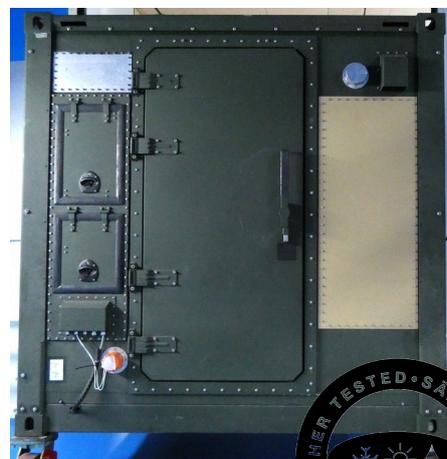
Side view

View from the door

Fig. 1. Equipment under test: Arctic Fox 10ft Shelter System.

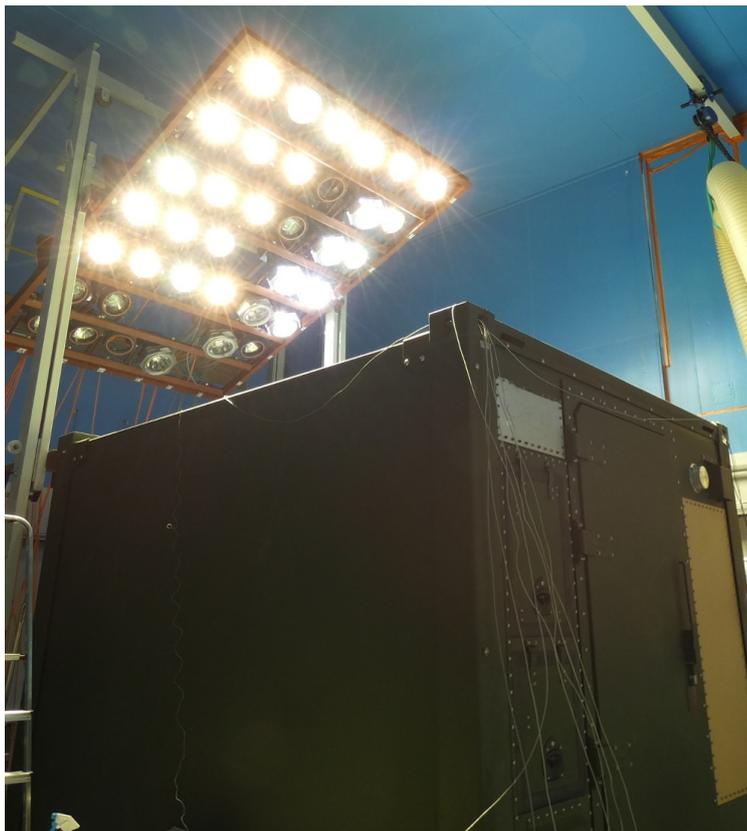
Fig. 5. Actual test situation.

The test arrangement is shown schematically in Fig. 4 and a photograph of the actual test situation can be seen in Fig. 5.

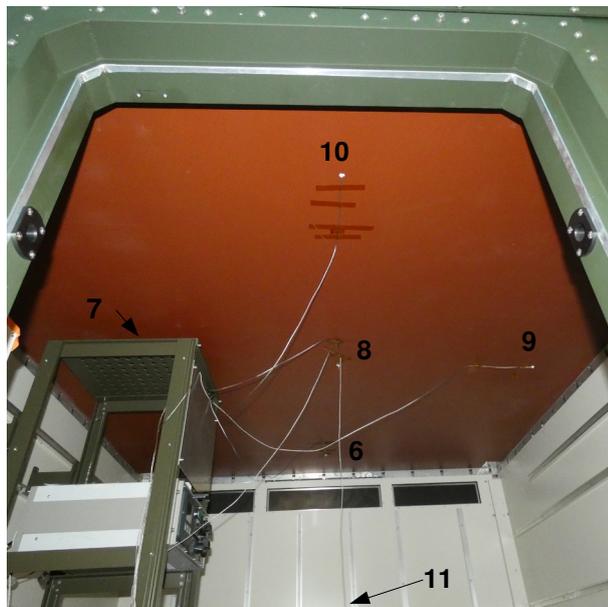
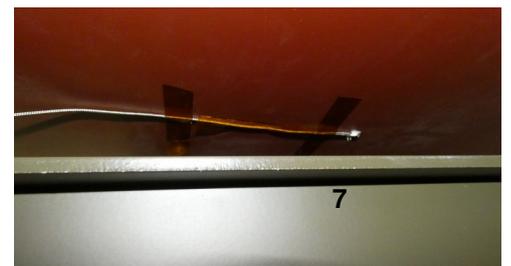
Fig. 7. Placement of the temperature and irradiance sensors. Heat-conductive adhesive was used to attach the sensors to the shelter surface, as can be seen in the close-up image of sensor No. 10.

K-type thermocouple temperature sensors were used to measure the surface temperatures of the roof and the ambient air temperature inside the shelter. The surface temperature sensors were placed in five pre-selected positions on the roof, at the same positions inside and outside the roof. The ambient air temperature sensor was in the center of the shelter interior. The thermocouple sensors were numbered as 1 – 11. The positions and numbering of the sensors are shown schematically in Fig. 6, and in more details in Fig. 7.

In addition, a Black Panel Thermometer (BPT) was placed on the roof, see Figs. 6 and 7.

The solar irradiation levels throughout the test area were measured and adjusted before testing with a precision pyranometer. During testing, the irradiance was monitored with a pyranometer placed on the roof, see Figs. 6 and 7.
